The BRWP RiverWatch Program

Hurd's Creek Catchment Report

October 2013
Revised April 2014

Bonnechere River Watershed Project

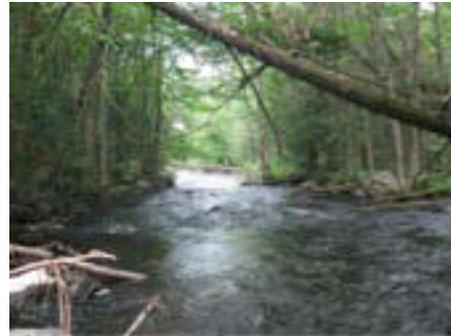
Shade is an important component to a stream ecosystem as it moderates the temperature of the stream. Shade is typically provided by an assortment of grasses, shrubs and trees and so this also contributes to other factors of stream health, such as providing a food supply (CityStream Watch 2011). Hurd's Creek is a fairly open stream system, with 82% of the stream open, and only 18% shaded (Figure 11).

Figure 11. Percentage of Hurd's Creek that is shaded versus open. The photo on the right depicts a shaded portion of Hurd's Creek. Photo taken in July 2013.

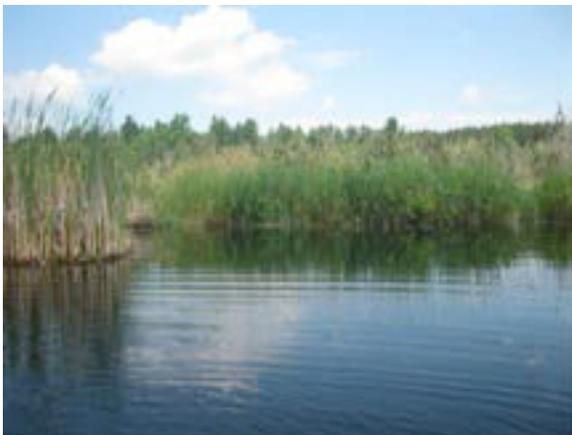
Photo on left depicts tall grasses and wetland vegetation growing adjacent to Hurd's Creek. Photo taken July 2013.

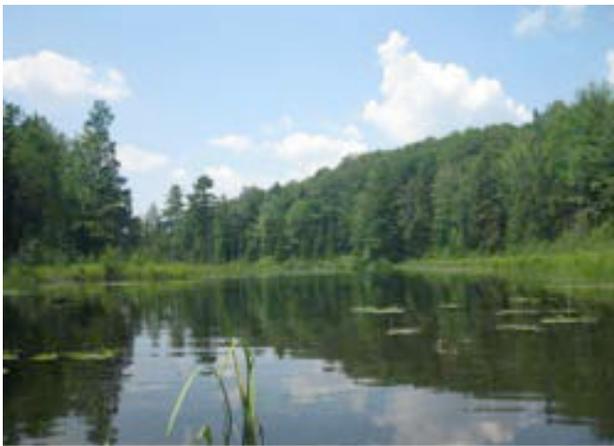
The photo on the left depicts a natural shoreline classification. Wetland grasses were found on the banks of the stream, while forests accounted for the adjacent land use to Hurd's Creek. Photo taken July 2013.
