The BRWP RiverWatch Program

Smith's Creek Catchment Report

October 2013

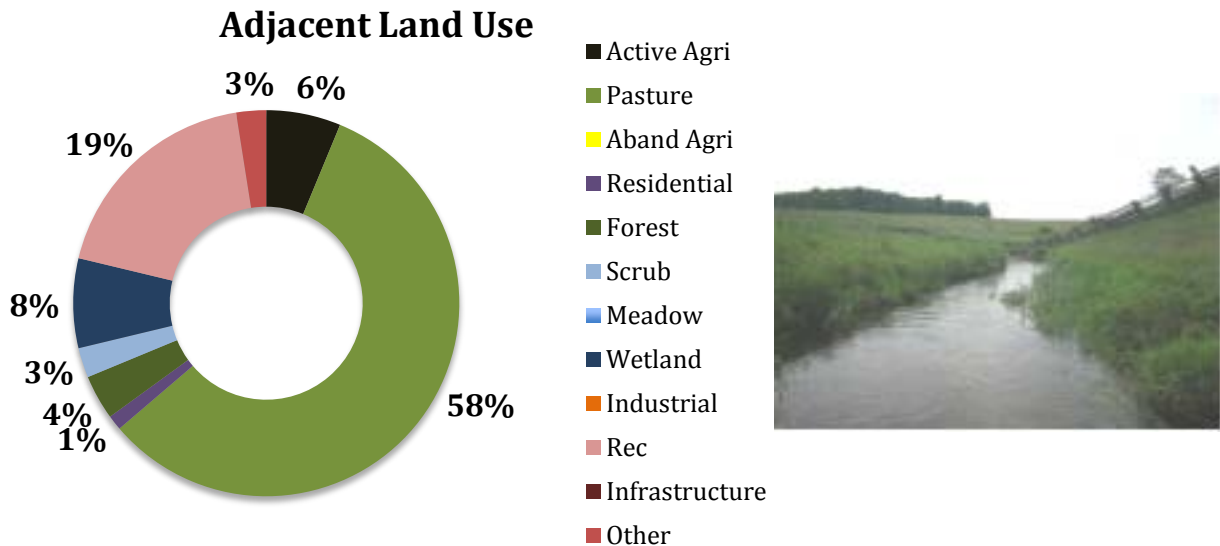
The land use adjacent to the creek varied, and there were eight different types of land use identified in Figure 3. Land use was largely agricultural, with 58% pastured land, and 6% active agriculture. Wetland areas were found within 8% of the areas surveyed and are an important natural component of stream habitat, filtering toxins from the water and providing important wildlife habitat. Forest and scrubland accounted for 4% and 3%, respectively. This vegetated buffer adjacent to the stream banks is important for filtering out excess nutrients, absorbing rainwater, and providing habitat for wildlife (CityStream Watch 2011). There was also a large portion (19%) that was considered recreational, where the creek ran adjacent to parks or pathways within the town of Renfrew. Also, 1% was considered residential. However, an increase in the number of surveys would most likely provide a more accurate representation of these land classes, as the stream does go through a portion of the town of Renfrew, however the survey entry points were within recreational parks and so, slightly biased. The surveys captured land use within the 100m transect, and up to 100m on either side of the stream.

Figure 3. Classes of land use occurring along Smith's Creek. Photo on right depicts adjacent agricultural land use along Smith's Creek. Photo taken in June 2013.

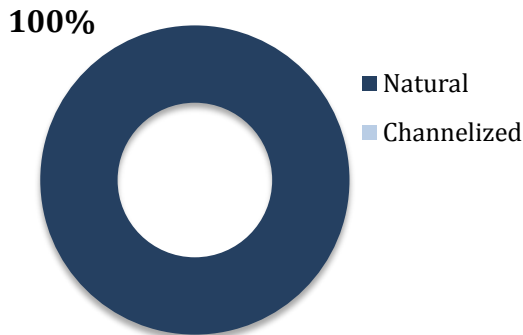
Figure 4. Channel type observed on Smith's Creek.

Figure 4 demonstrates that Smith's Creek was 100% natural, containing pools, riffles and runs with unaltered stream banks. The creek meandered through the landscaped unaltered, and maintained a natural sinuosity, with no alteration to form any kind of straightened channel, ditch or drain.

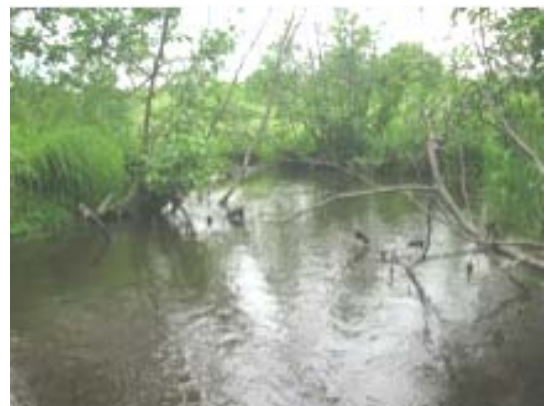
The types of features found in a stream are dependent on the stream substrate and depth. Figure 5 shows that 89% of the surveyed areas of Smith's Creek were characterized by runs; areas of moderately shallow unagitated water, where the thalweg (deepest part of the channel) is found in the center of the stream. 9% of the surveyed stream was characterized by pools; areas where deeper pockets of water are found, typically between riffles. Pools are important shelter area for stream wildlife, providing refuge if stream levels decrease, as well as over-wintering areas. Riffles were only found in 2% of the surveyed stream. Riffles are areas with agitated water surface, with moderate to rapid current velocity and are important for oxygenating the water (CityStream Watch 2011).

Figure 5. Instream morphology of Smith's Creek. Photo taken in June 2013.

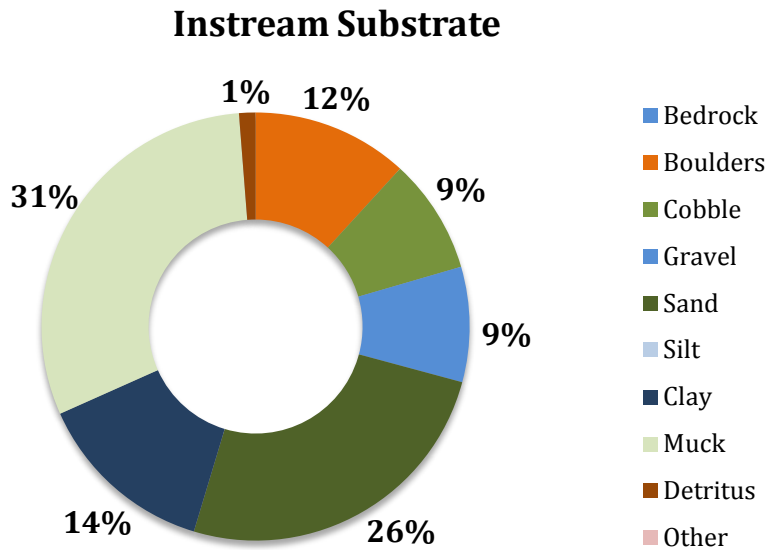
Figure 6. Types and percentage of instream substrate along Smith's Creek.

Diverse instream substrate types will allow for a greater diversity of instream wildlife, as different species will secure different habitat niches. There was a variety of substrate types found in Smith's Creek, however there was a propensity for finer-particle substrates such as muck (31%), sand (26%), clay (14%) and gravel (9%) (Figure 6). Larger-particle substrate such as cobble (9%) are important over wintering and/or spawning habitat for small and juvenile fish, and boulders (12%) provide back eddies for larger fish to hide and rest out of the current (CityStream Watch 2011).

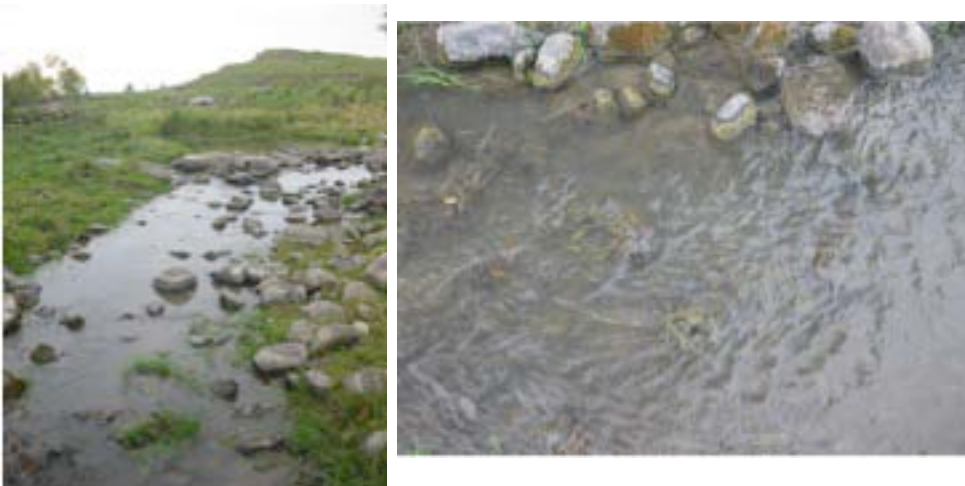
Both photos depict boulder and cobble substrate along a portion of Smith's Creek. Photos taken in June 2013.

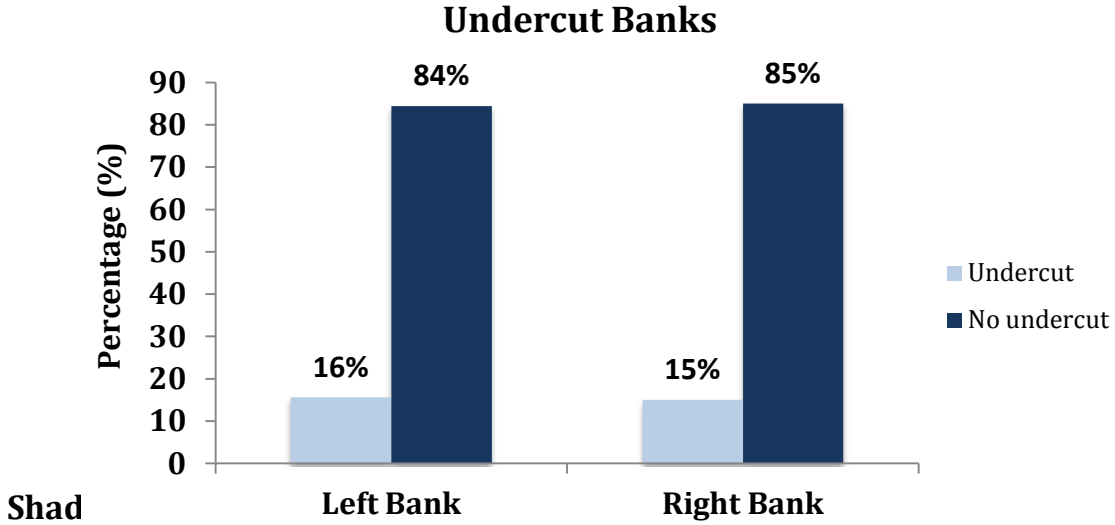
Figure 10. Percentage of undercut banks on the left and right banks of Smith's Creek.

The percentage of undercut banks was approximately equal on both sides of Smith's Creek and accounted for 15-16% of the stream surveyed (Figure 10). Undercut banks are part of a normal stream ecosystem and provide refuge areas for fish.

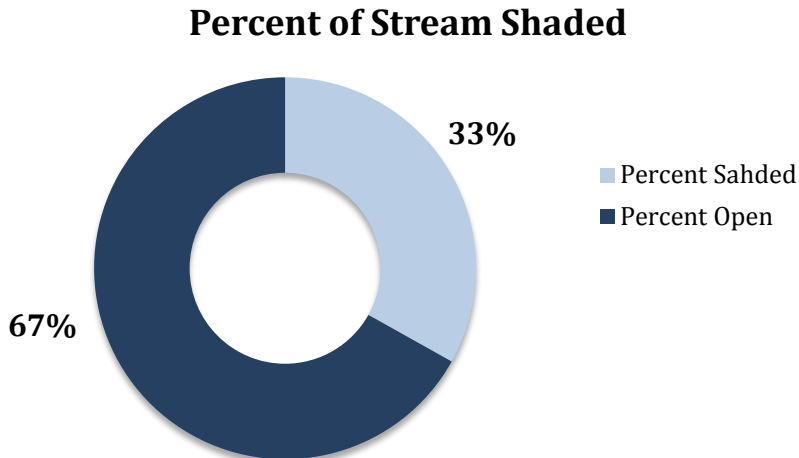
Figure 11. Percentage of Smith's Creek that is shaded versus open.

Shade is an important component to a stream ecosystem as it moderates the temperature of the stream. Shade is typically provided by an assortment of grasses, shrubs and trees and so this also contributes to other factors of stream health, such as providing a food supply (CityStream Watch 2011). Smith Creek is a fairly open stream, with 67% of the stream open (Figure 11). However, there may be a slight sampling bias, as more woody portions of the creek at the headwaters were not surveyed due to difficulty in accessing those portions of the creek.

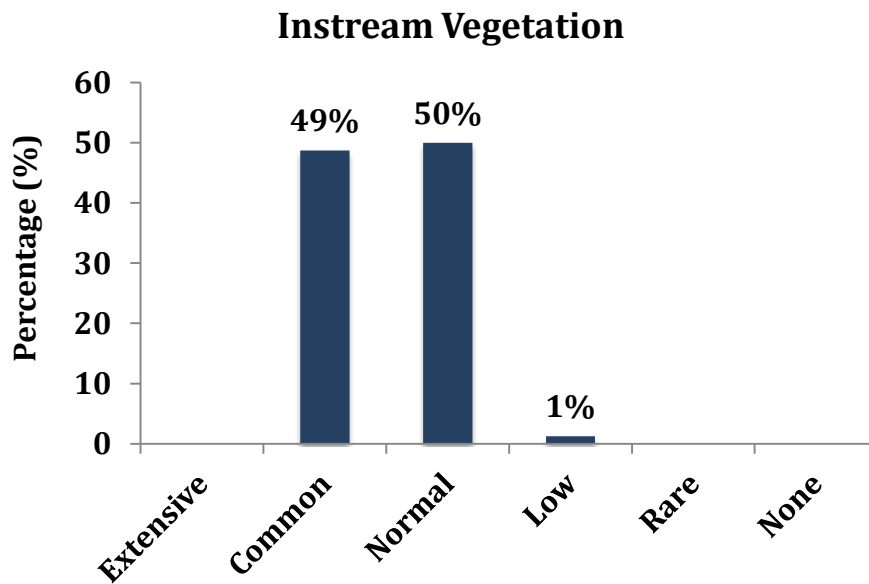
Instream vegetation plays an important role in maintaining a healthy stream ecosystem. Plant processes help maintain clean and oxygenated water through the removal of contaminants and production of oxygen through photosynthesis (CityStream Watch 2011). However, vegetation is only beneficial within a normal range, as too much vegetation (or the wrong kind of vegetation) can be detrimental to stream health and an indicator of poor water quality. Instream vegetation in Smith's Creek was within an appropriate range. Figure 12 shows that the surveyed portion of the stream showed that 99% of the vegetation was considered to be either common or normal levels. While the remaining 1% was classed as low instream vegetation.

Figure 12. Percentage of instream vegetation separated into classes (extensive: choked with vegetation, common: >50% vegetation, normal: 25-50% vegetation, low: <25% vegetation, rare: few vegetation, none: zero vegetation) found within Smith's Creek.

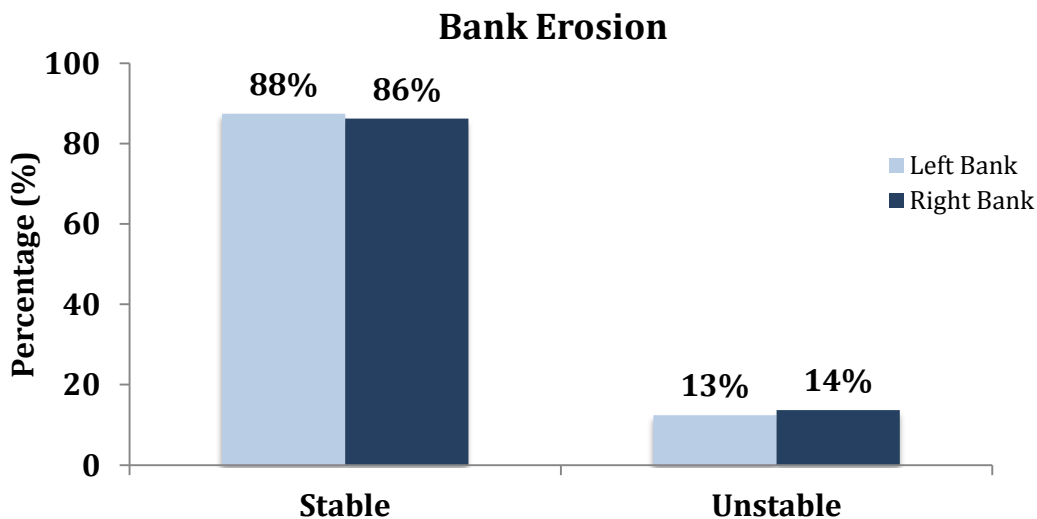
Figure 14. Percentage of bank erosion found on the left and right banks of Smith's Creek.

Bank erosion is part of the normal process within a stream ecosystem, however if it becomes extensive it can lead to sedimentation within the stream, which can affect fish and wildlife habitat. Erosional tendencies within a stream will be largely dependent on the stability of the banks. A stable bank will resist erosional processes and will likely have a higher level of bank vegetation that will help to stabilize the soils. An unstable bank does not have the support system to retain the soil, and will lead to greater sedimentation and even bank failure if erosional processes are great enough (CityStream Watch 2011). The surveyed portions of Smiths Creek indicate that the majority of the banks are stable (88% left bank, 86% right bank), and there was not a significant difference in stability between the left and right bank (Figure 14).

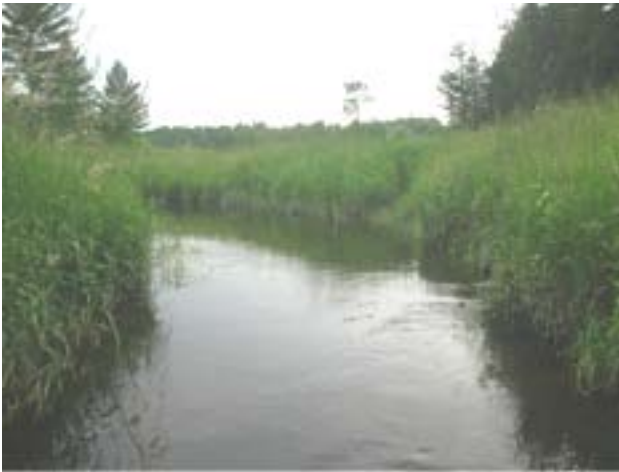
Photo on left depicts tall grasses that are growing adjacent to Smith's Creek. This type of bank vegetation was most prevalent on Smith's Creek, accounting for 56% of vegetation on the left bank and 53% on the right bank. Photo taken in June 2013

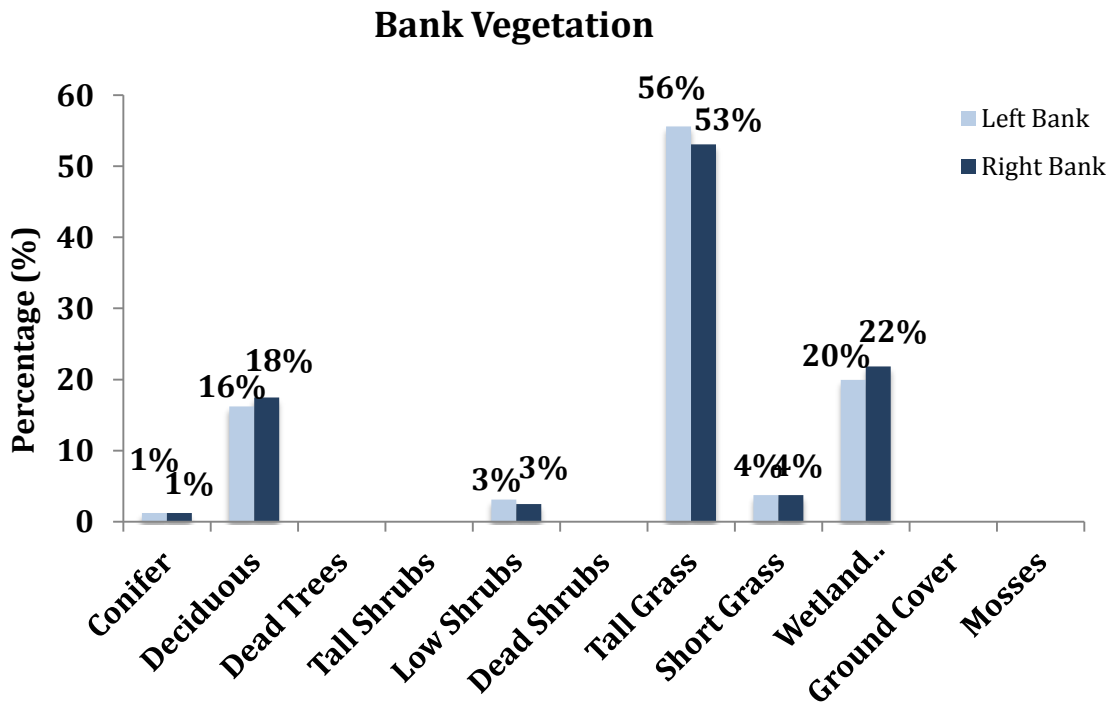
Figure 15. Percentage of vegetation types found on the left and right banks of Smith's Creek. ^{1/2}

A large percentage of vegetation types along the banks of Smith's Creek were grasses (Figure 15); tall grasses (56% left bank, 53% right bank), and short grasses (4% both banks). This is not surprising as a large portion of the surveys were done near agricultural areas. There was also a significant wetland area along the banks (20% left bank, 22% right bank). Wetlands are vital to healthy ecosystems as they remove pollutants, protect against flooding and erosion and provide habitat for wildlife (Cappiella and Frely-McNeal 2007). Forest also covered a portion of the surveyed banks, with deciduous trees (16% left bank, 18% right bank) and coniferous trees (1% both banks). Trees are important to stream health as their root systems help to stabilize the banks and prevent erosion and sedimentation, as well leaf litter contributes nutrients into the stream (CityStream Watch 2011).

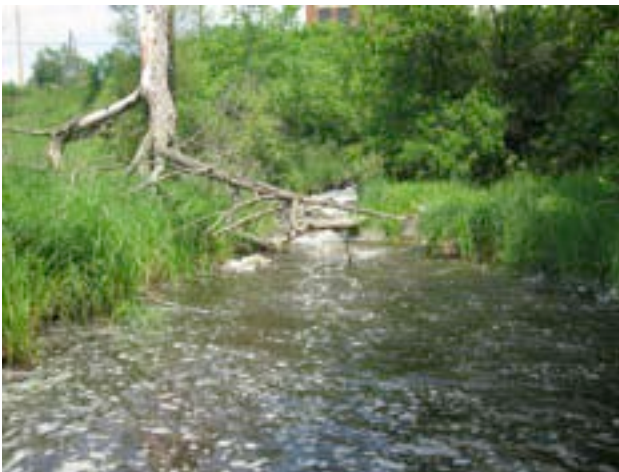
The photo on the left depicts a regenerative shoreline classification. The left bank was largely wetland grasses and natural vegetation, while the right bank was part of a park in the town of Renfrew that had been re-vegetated with native shrub, tree and wildflower species. There was also some disturbed shoreline on the right side, where mowed grass reached almost to the stream's bank. Photo taken in June 2013.

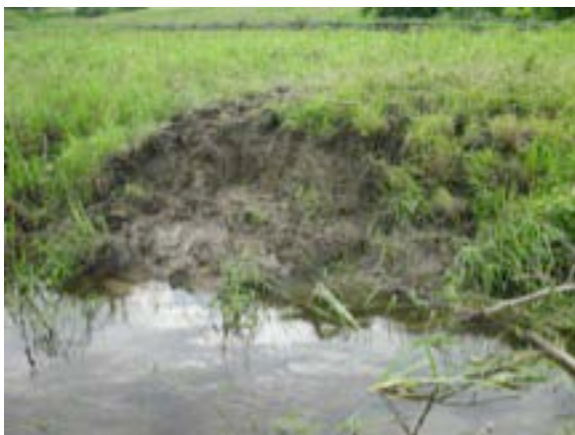
Figure 19. Example of destabilized banks due to cattle activity along Smith's Creek. Photo taken in June 2013.

along stream banks to produce an adequate riparian buffer zone. This was particularly an issue along the left bank of Smith's Creek, as manicured lawns within the town of Renfrew often went quite close to the stream. Garbage cleanup was identified as a need at 25% of the surveyed sites. Again, this was particularly relevant once the stream entered the town of Renfrew, particularly within the recreational areas (parks and pathways). Invasive species control was identified as an enhancement opportunity at 12.5% of surveyed sites. One of the more common invasive species identified was the rusty crayfish, which competes with the native crayfish species. Cattle restriction was identified as a major issue within the Smith's Creek catchment, with restriction measures needed at 50% of the surveyed sites. Cattle were often found meandering right down to the creek banks, with no restriction to the water source. Cattle in the creek can be a problem as they destabilize the banks (Figure 19), and contribute excess nutrients to the stream system through their feces.
